NORWALK RIVER BASIN  
GEORGETOWN CONNECTICUT

# FACTORY POND DAM CT 00217

## PHASE I INSPECTION REPORT NATIONAL DAM INSPECTION PROGRAM

JULY 1980

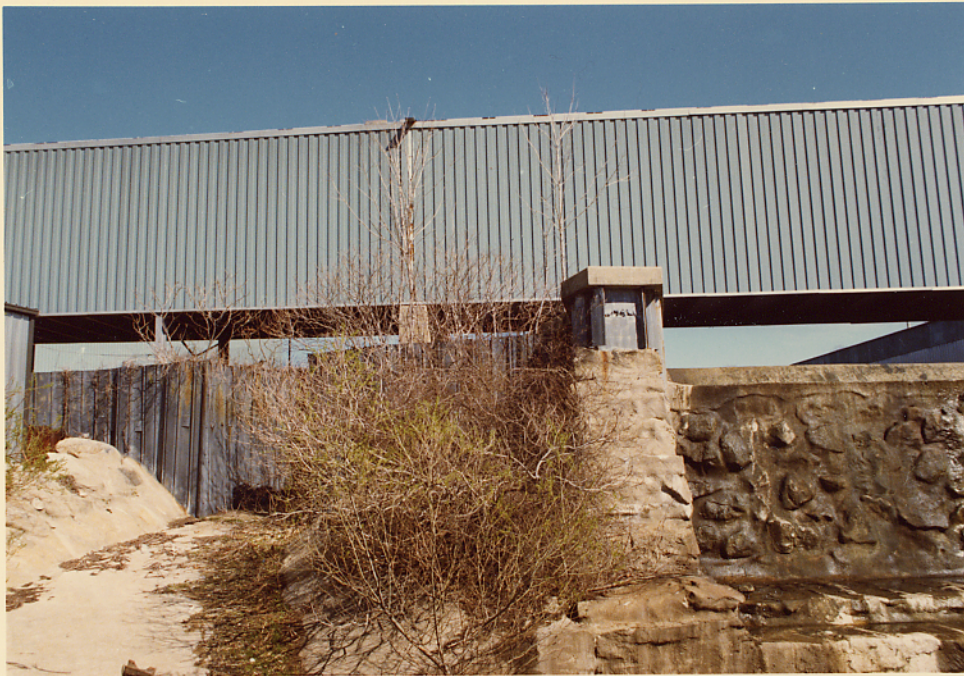
b. Dam - The dam is a combination of sheet piling/concrete fill and masonry. The sheet piling and concrete fill are in good condition (Photo 1). The sheet piling is painted with some areas that are rusting. The concrete cap is in good condition with no cracking (Photo 3). There is no evidence of settlement or lateral movement. There are some areas along the toe where vegetation is growing (Photo 1). The masonry portion of the dam is fair with some joints in need of repointing (Photo 8).

The spillway is a fixed weir that appears to be in fair condition (Photos 2 and 5). The downstream training wall and western abutment (Photos 1 and 6) show some seepage and cracks.

PHOTO 1  
DOWNSTREAM FACE OF DAM

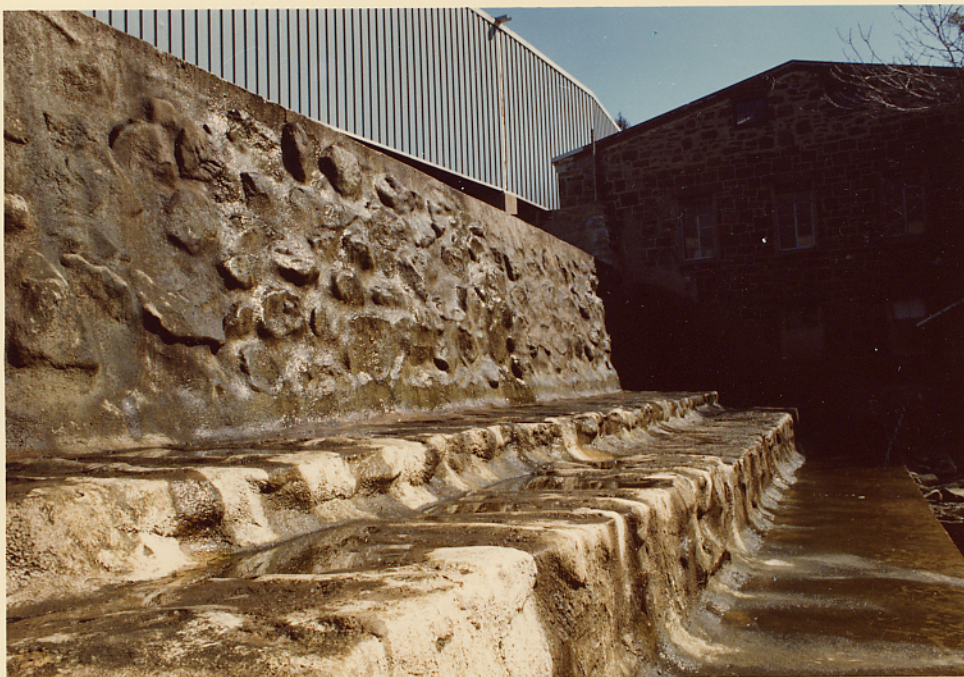
PHOTO 2  
DOWNSTREAM FACE OF DAM

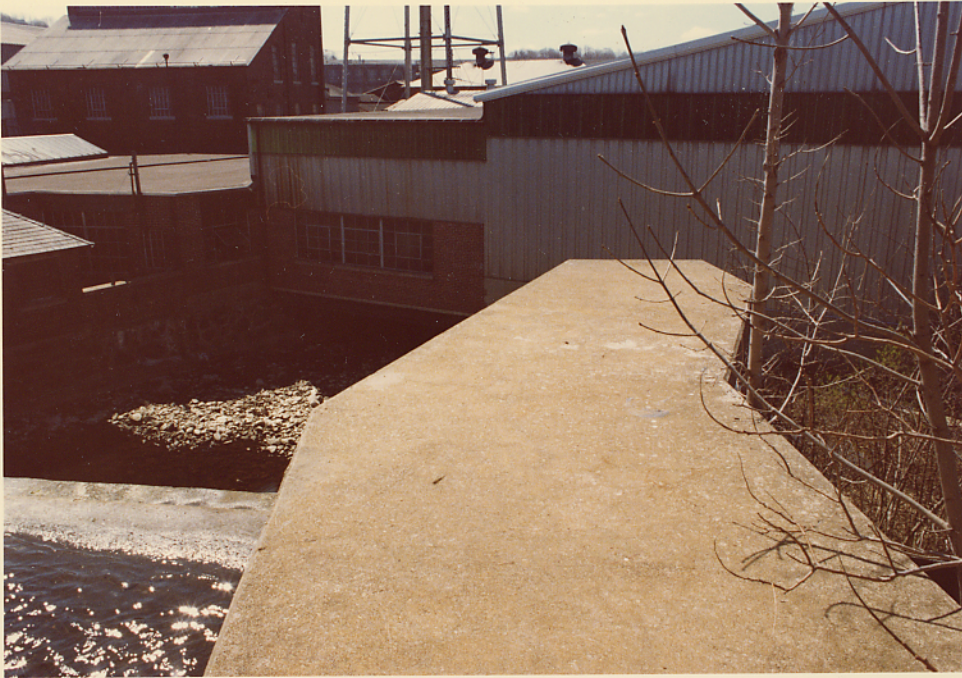
PHOTO 3  
DOWNSTREAM CHANNEL

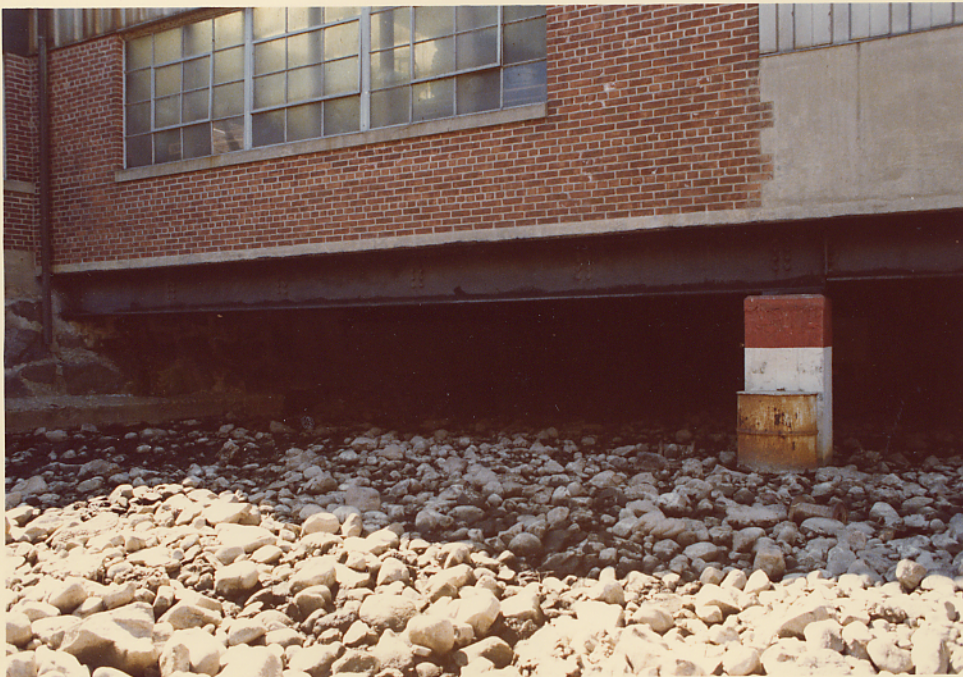
PHOTO 4  
DOWNSTREAM CHANNEL

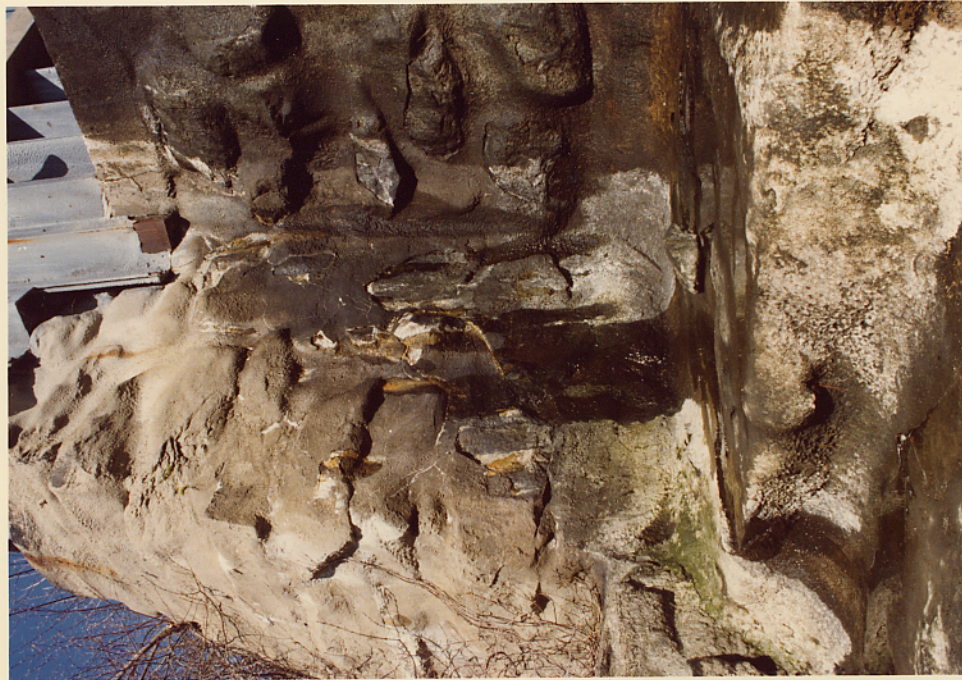
PHOTO 6

The only area of concern is at the western abutment/training wall where there is some cracking and some seepage. This seepage, at the time of inspection, was negligible.

SEEPAGE THROUGH WEST SPILLWAY ABUTMENT

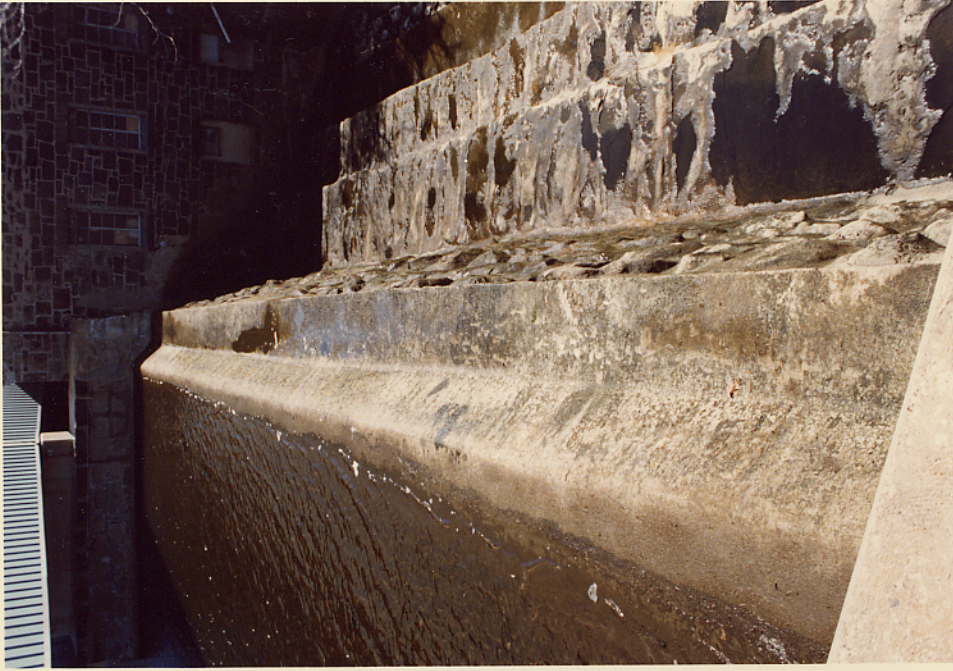
PHOTO 5

SPILLWAY CREST

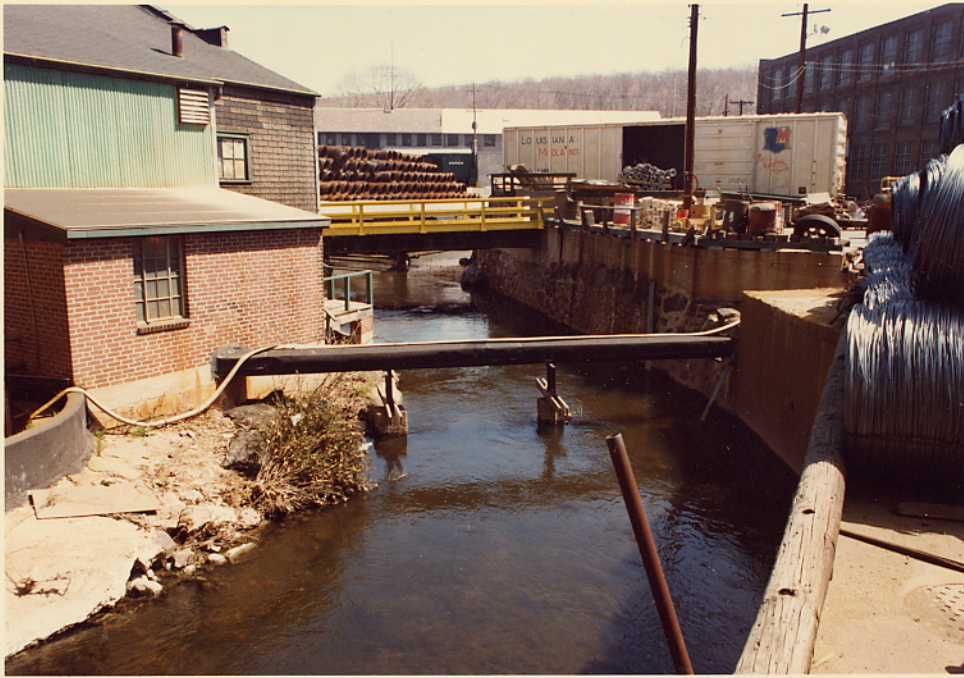
PHOTO 7  
DOWNSTREAM CHANNEL

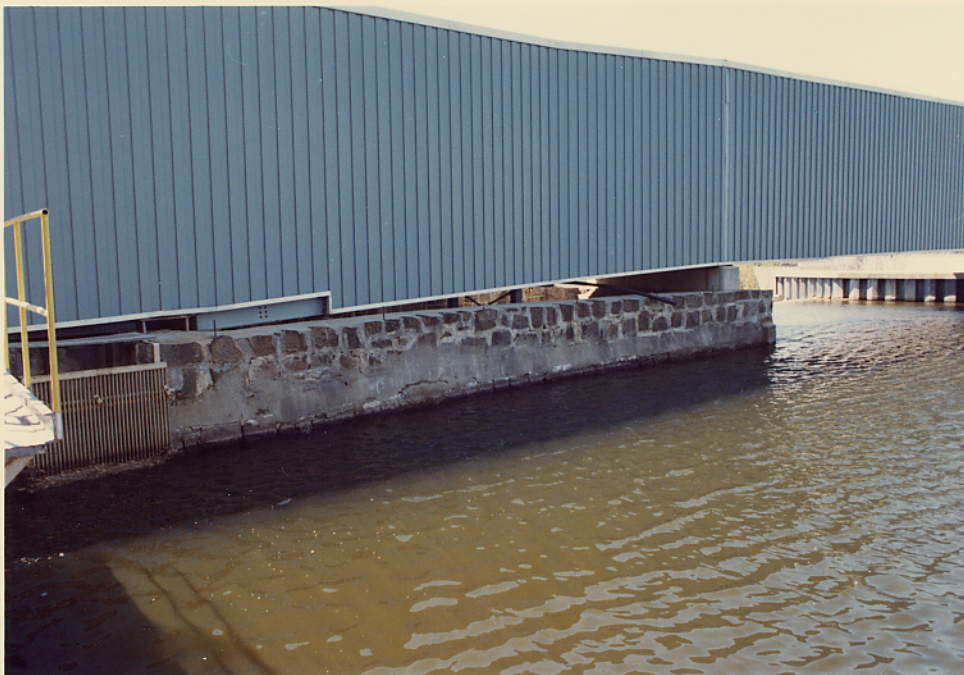
c. Appurtenant Structures - The inlet to the discharge conduit is protected by a bar screen which is in good condition. The discharge conduit itself was underwater and could not be inspected (Photo 8). The conduit contains a power turbine which is not used. The control for this conduit is by varying the pitch on the blades of the turbine. The gate is operable and the conduit was in use at the time of inspection.

PHOTO 8  
SCREEN & DIVERSION INTAKE  
UPSTREAM FACE OF DAM  
C-IV

(1) Repair all cracks and mortar all joints in the masonry portion of the dam.
